## Cover Page

On-Site Property (Facility) Name: Former F.J. Doyle Transformer Salvage/Recycling Facility  
 Street no. 905 Pre dir: N. Street name: Poplar Street type: St Post dir: \_\_\_\_\_  
 City: Leonard County: Fannin County Code \_\_\_\_\_ Zip 75452  
 Nearest street intersection and location description: 0.344 acres, SW Corner of N. Poplar St and E. Cottonwood St  
 Latitude: Decimal Degrees (indicate one) North 33.389437  
 Longitude: Decimal Degrees (indicate one) West 96.243147

# Executive Summary

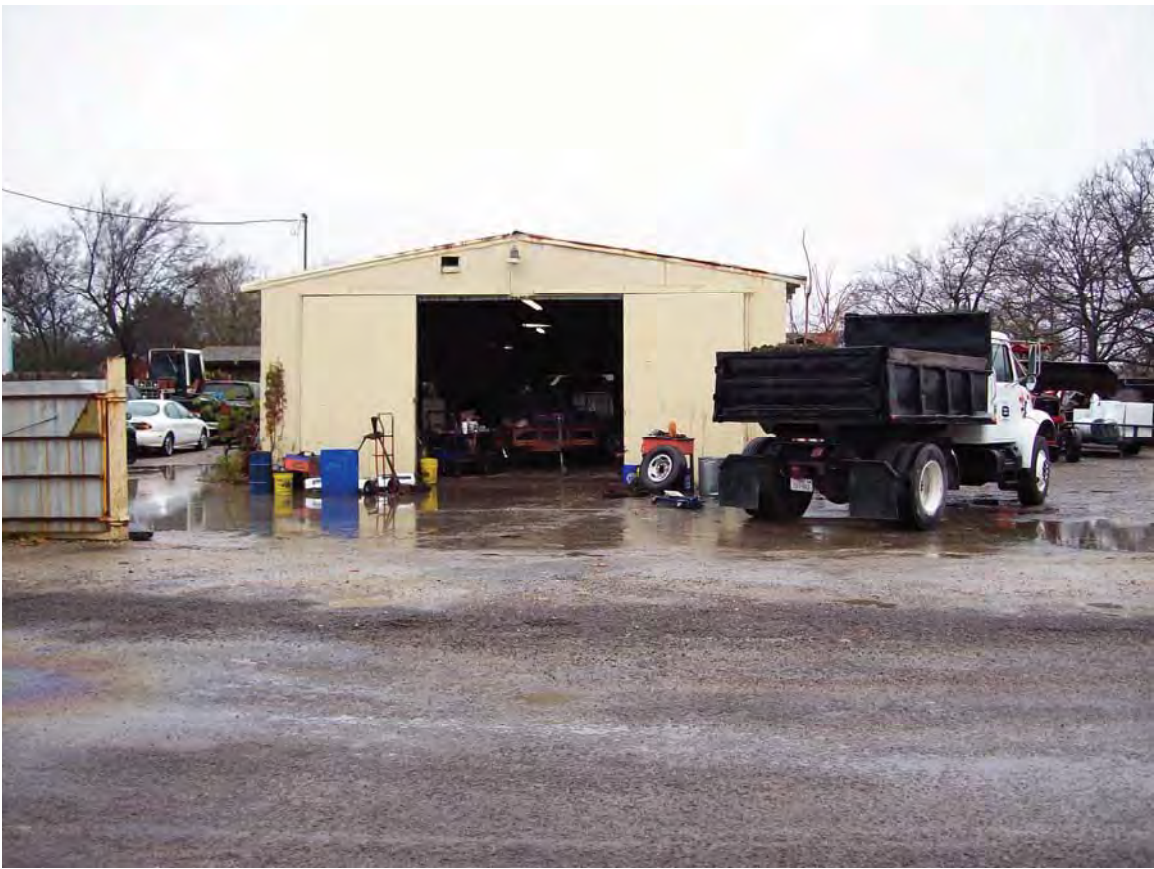
Photograph 1: View looking west of the automobile repair shop building. This building was previously used as the transformer recycling facility.

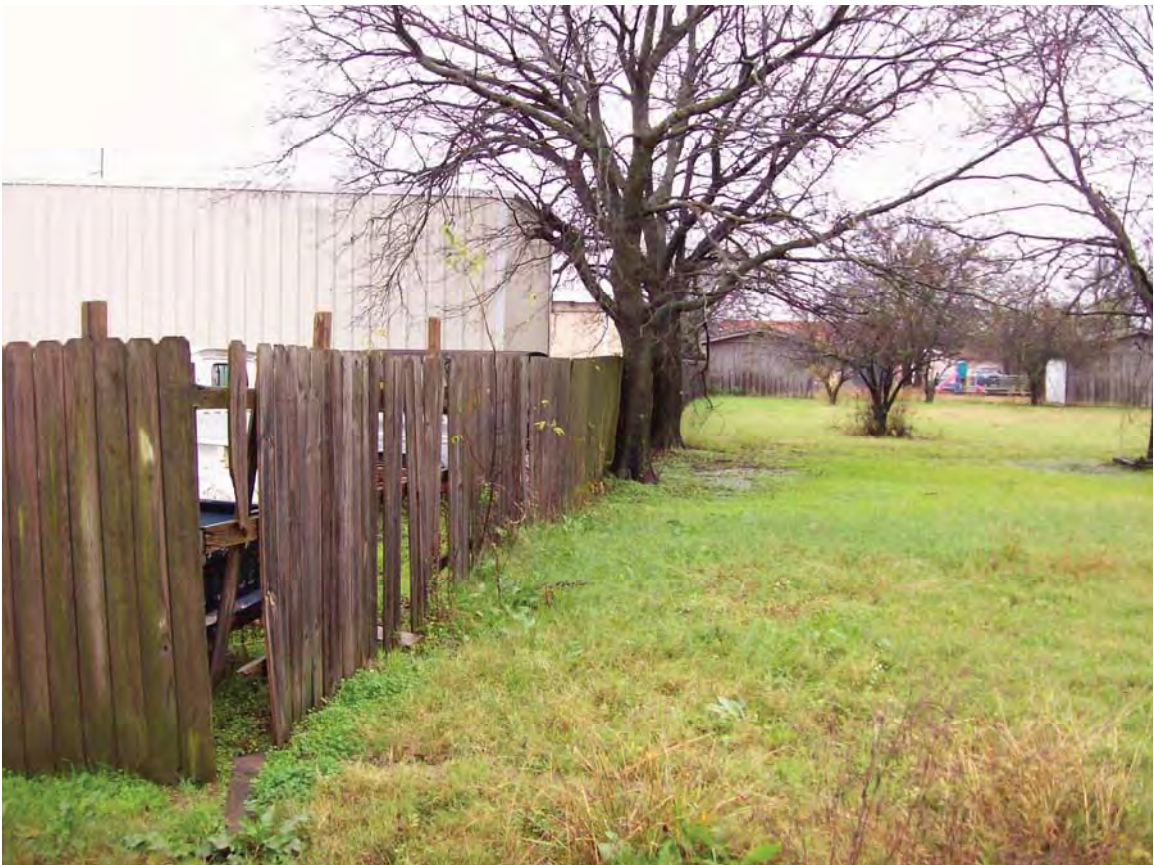
Photograph 2: View looking south of the west property boundary showing the shed (left) and the vacant lot located west of the site.

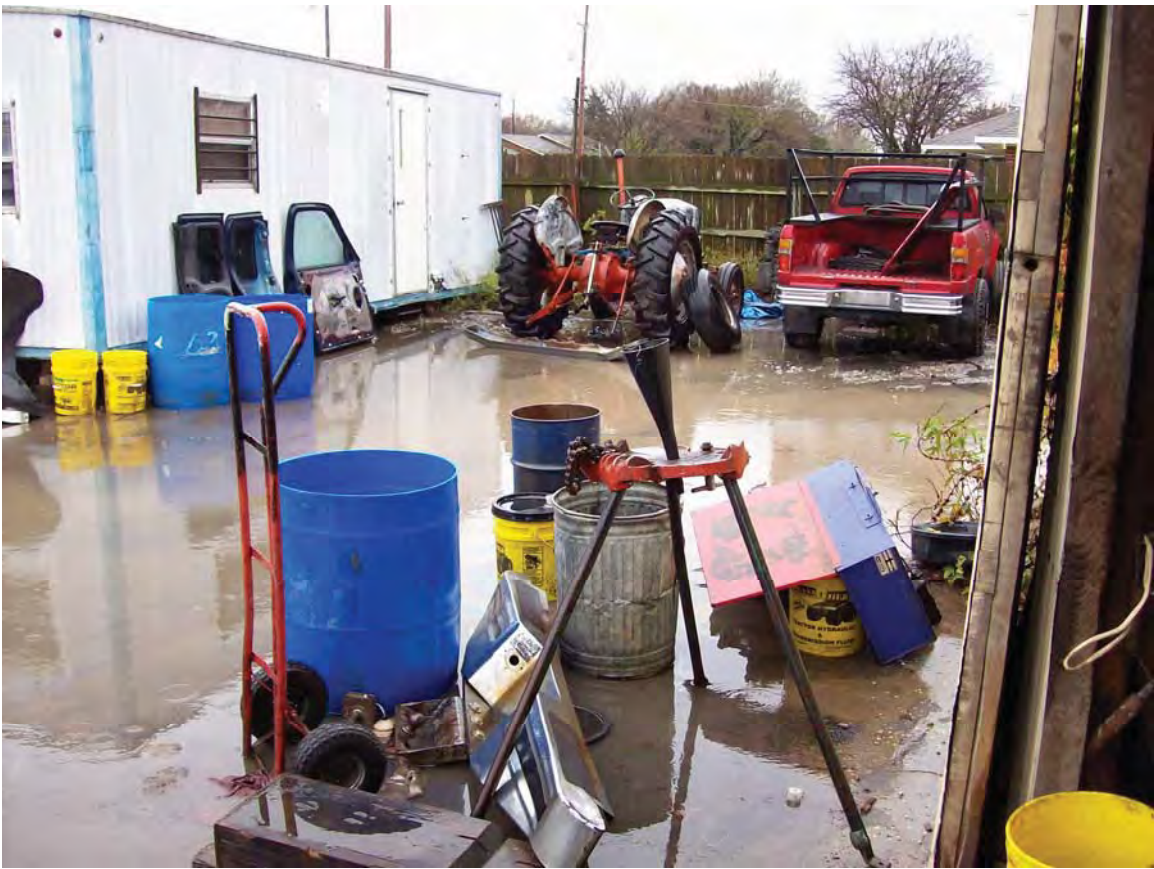
Photograph 3: View looking southeast of the portable building and of the exterior of the automobile repair shop.

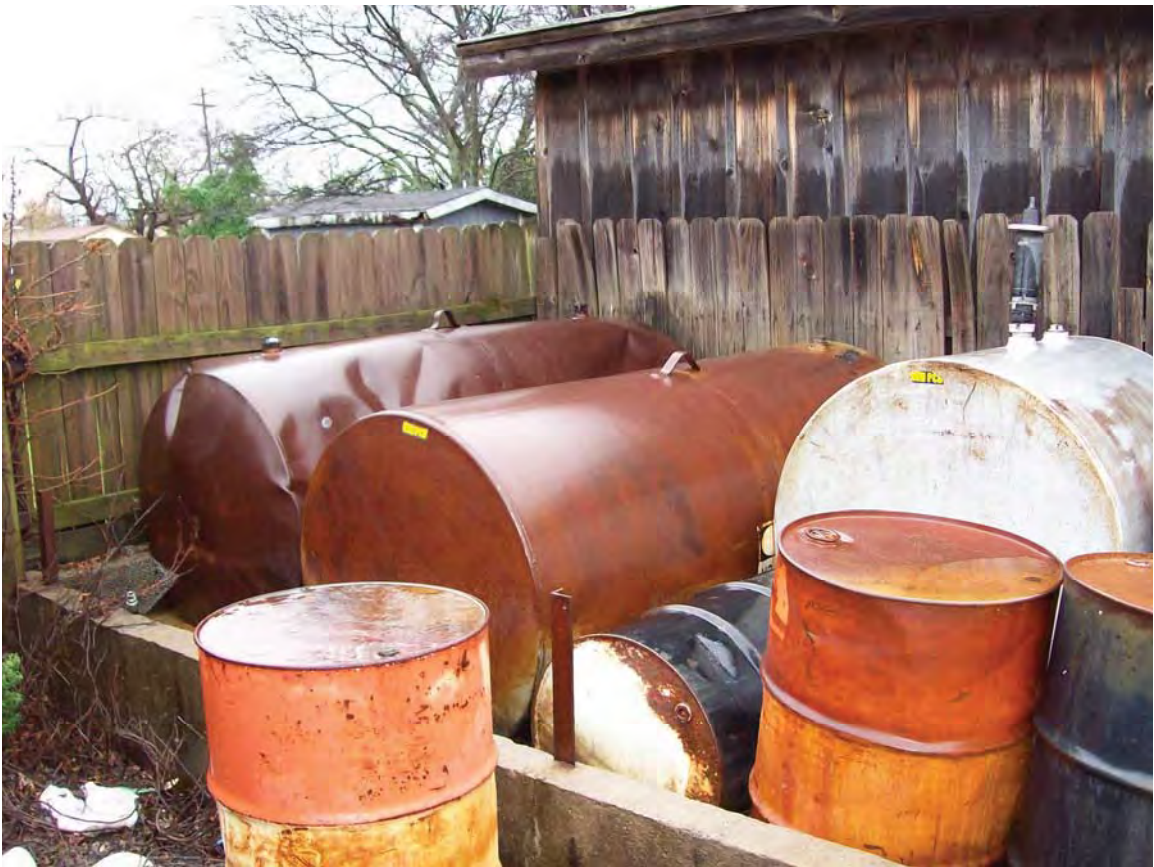
Photograph 4: View looking northwest the three aboveground storage tanks and multiple 55-gallon drums in and near the spill containment sump.

- A kerosene-dispensing AST was observed on the north side of the shop building. The AST appeared to be empty, but this could not be confirmed.
- Numerous 55-gallon drums of new/used oil and hydraulic fluid are located in and around the shop and numerous used and emptied drums are stored in and around the secondary containment basin.

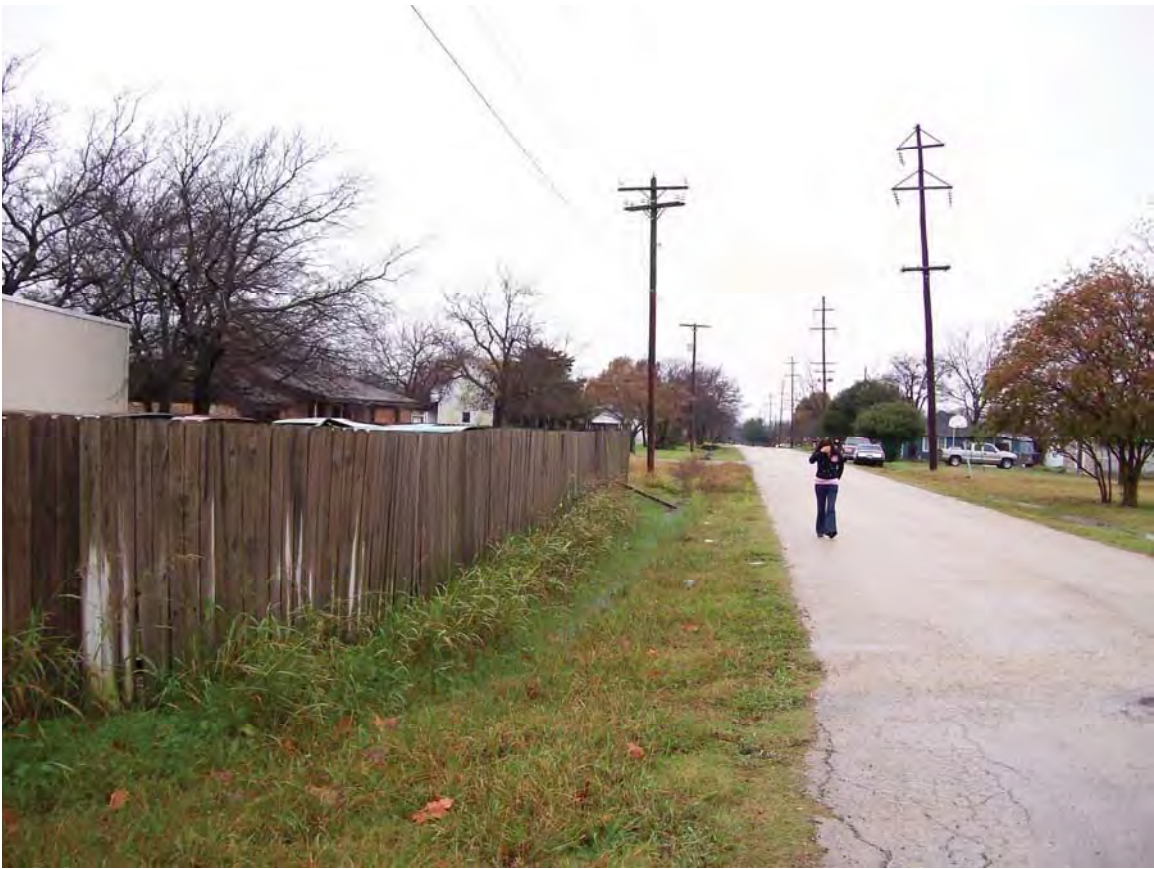
Photograph 5: View looking west showing the northern property line with E. Cottonwood Street and the residential neighborhood beyond.

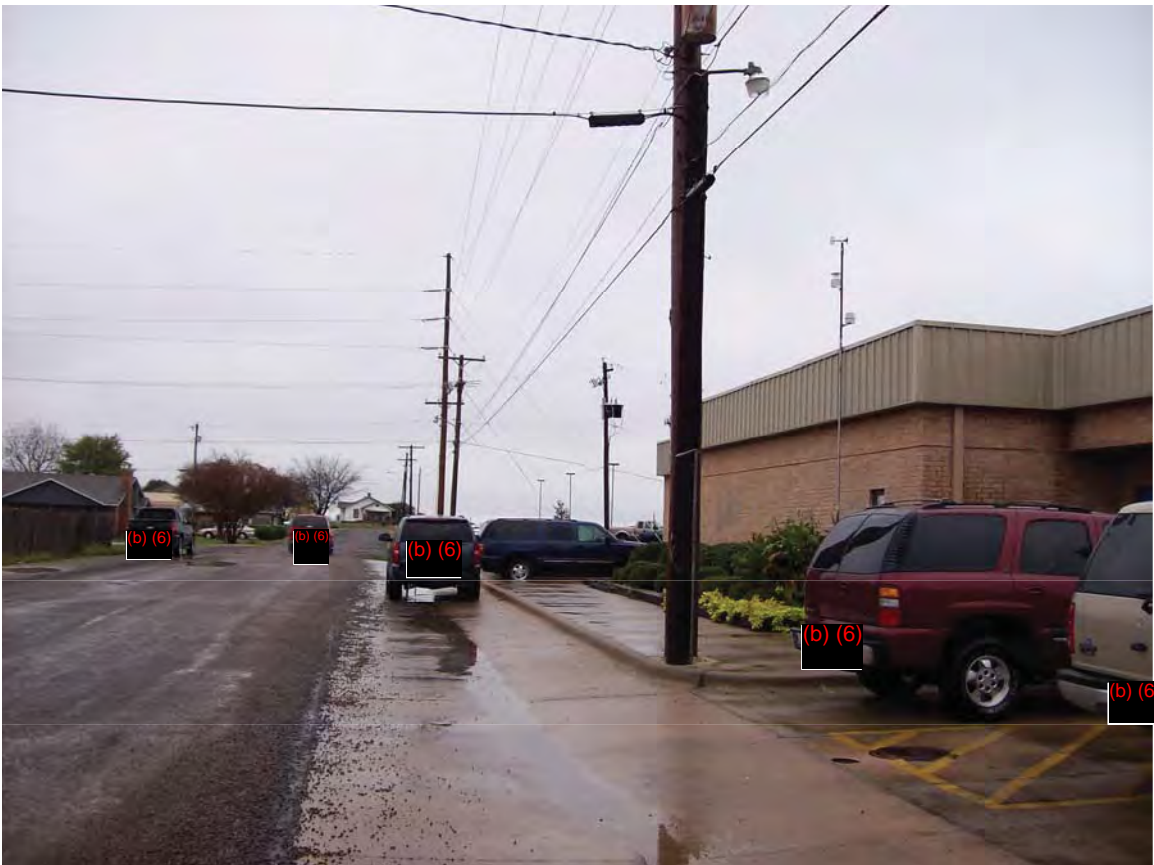
Photograph 6: View looking north along N. Poplar Street showing the school buildings east of the site. Also note the one transformed on the power pole in the foreground (#N6497) and in the three in the background (Nos. N23508, N21884, and N21888).

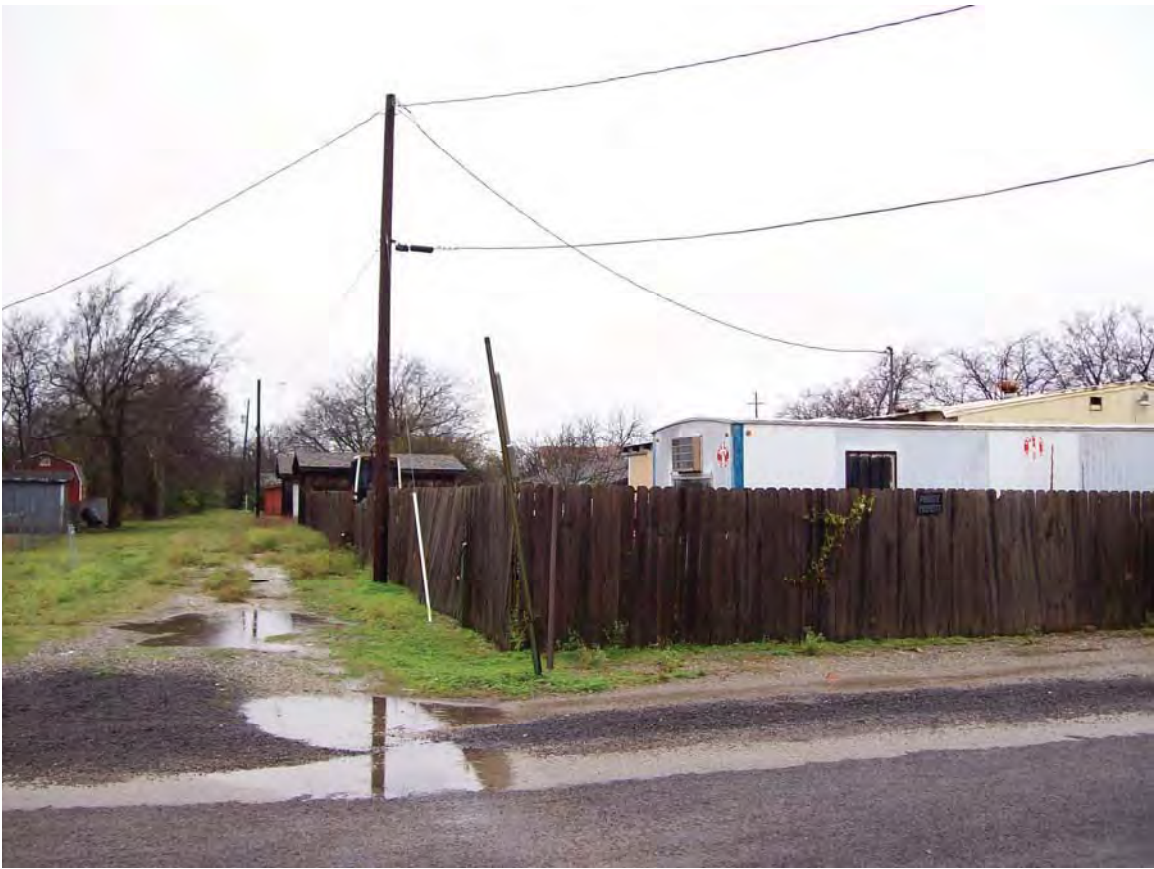
Photograph 7: View looking west of the alleyway south of the site with the residences beyond.

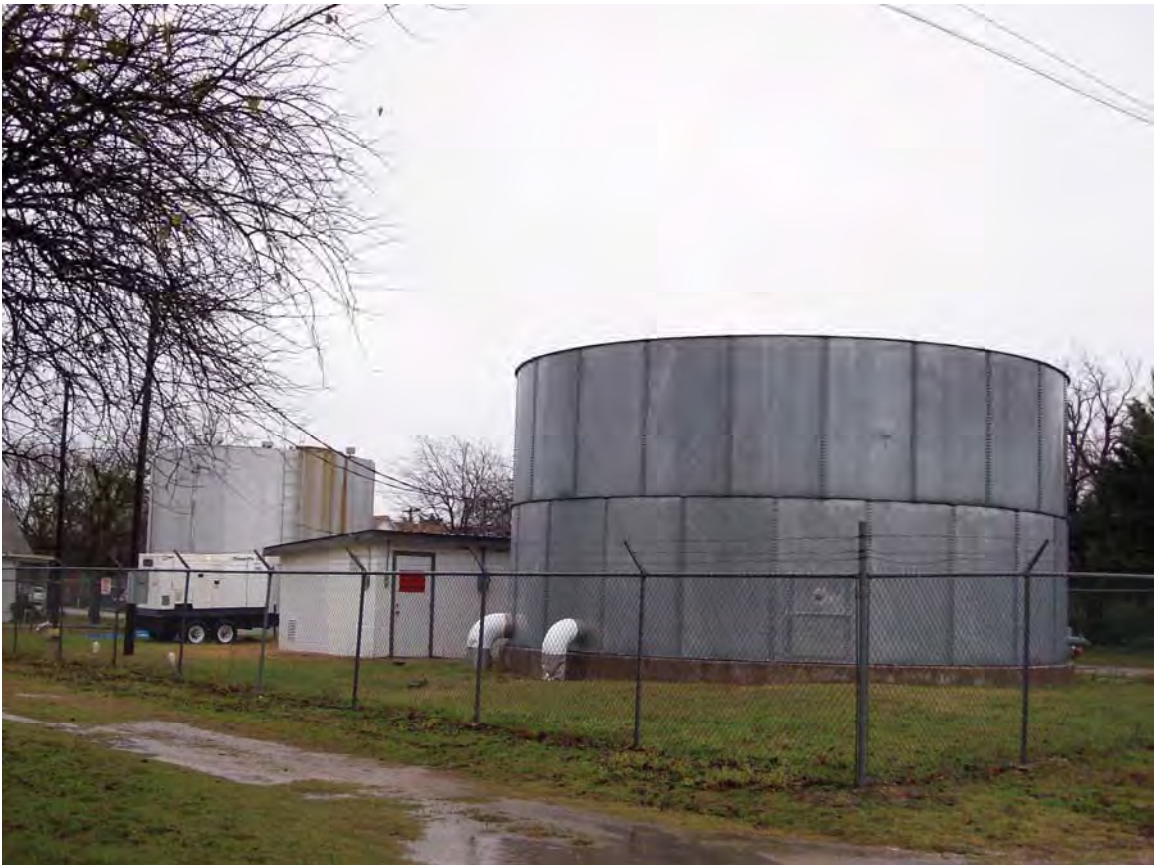
Photograph 8: View looking southeast of City Water Well #1 and its storage tanks located approximately 370 feet from the site

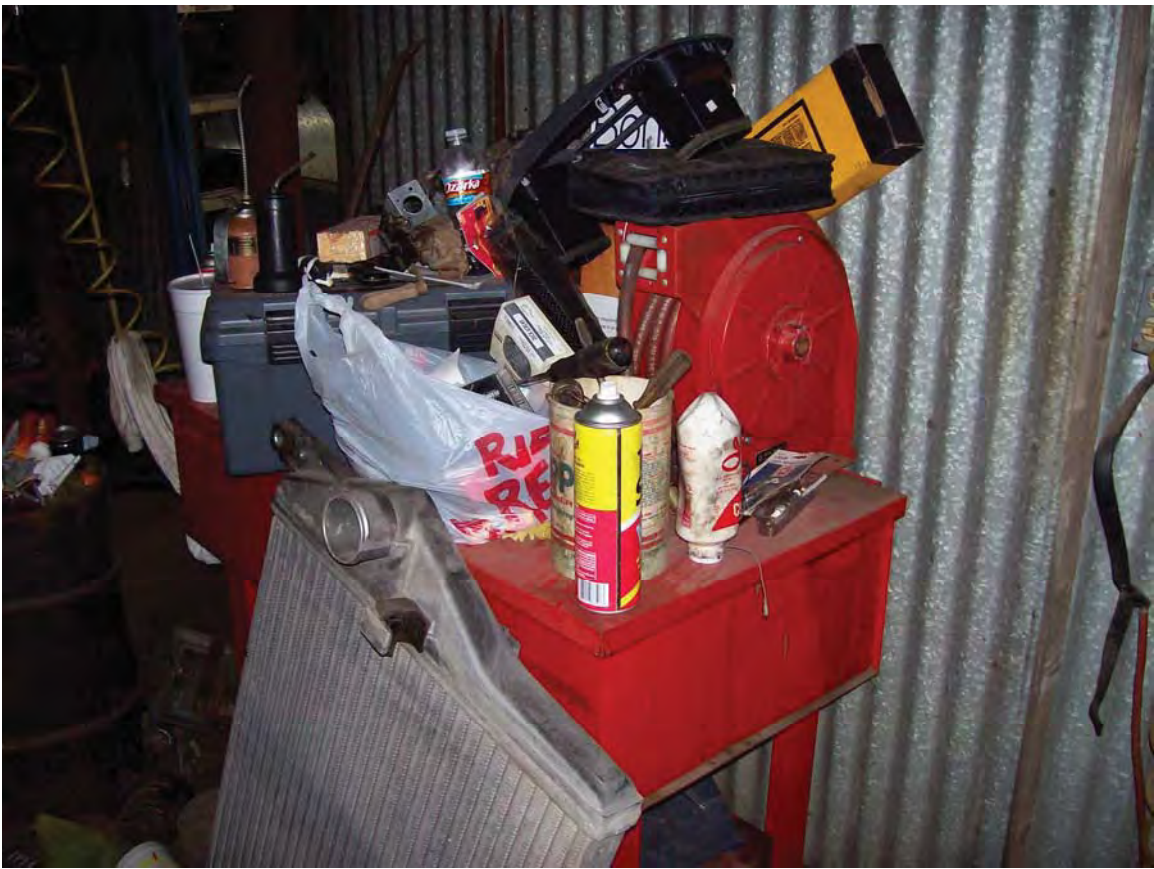
Photograph 9: View inside the shop building showing the parts washer and other chemicals.

- Terra-Solve observed a solvent parts washer in the warehouse repair area. The warehouse and office storeroom also store various amounts of general cleaning and general maintenance supplies.

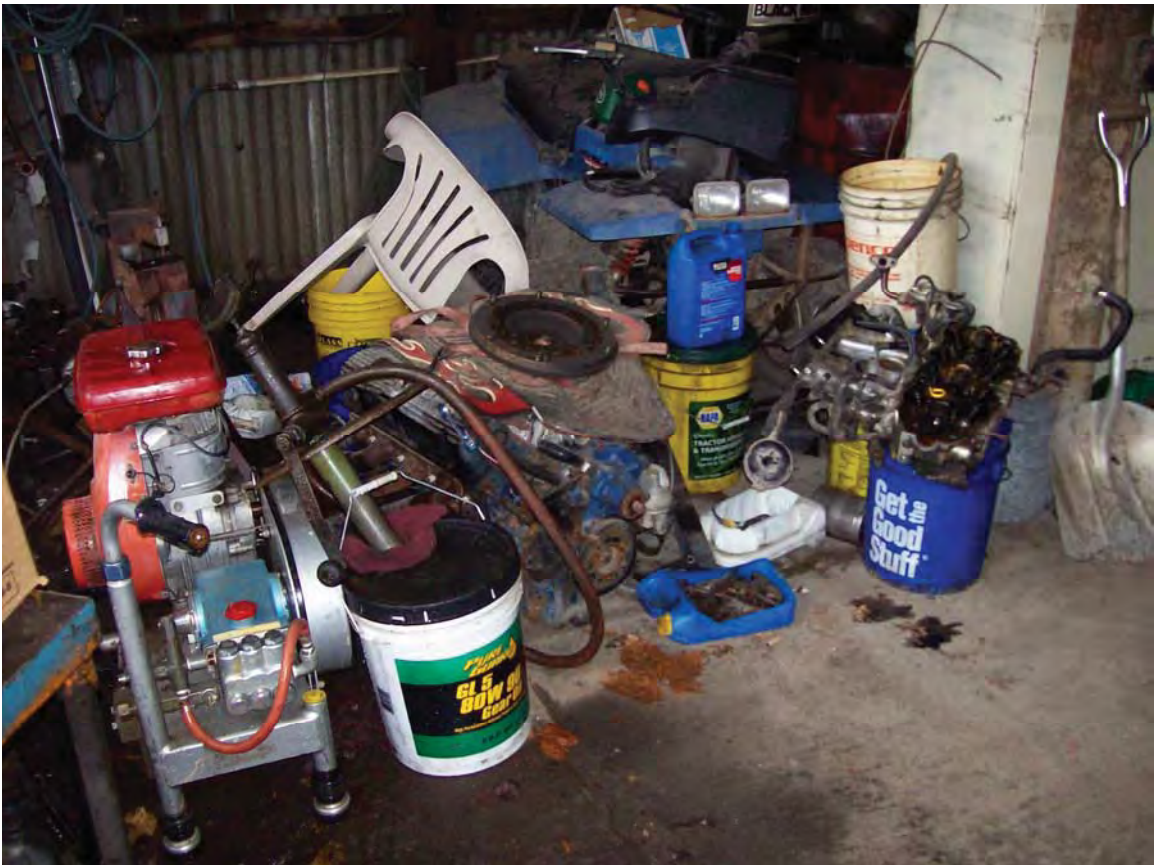
Photograph 10: View inside the shop building showing 5-gallon buckets of chemicals and oil, both new and used. Numerous areas of stained concrete are visible in the shop.

- Numerous areas of oil staining were observed on the concrete inside the shop building and staining was observed near the secondary containment basin and hydrocarbon sheens were observed in the parking lot.

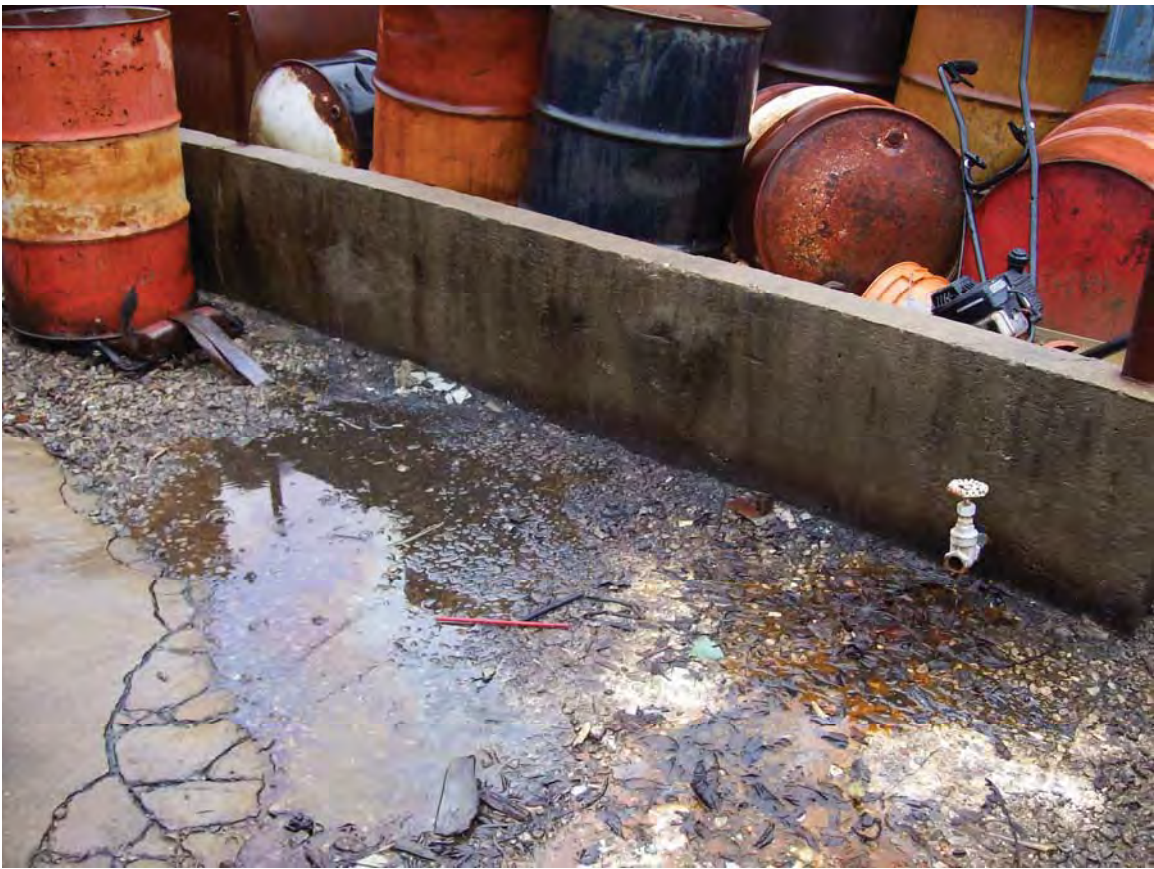
Photograph 11: View looking southwest of the drums inside and outside the AST secondary containment basin. Note the drain valve and the stains and hydrocarbon sheen on the standing water.

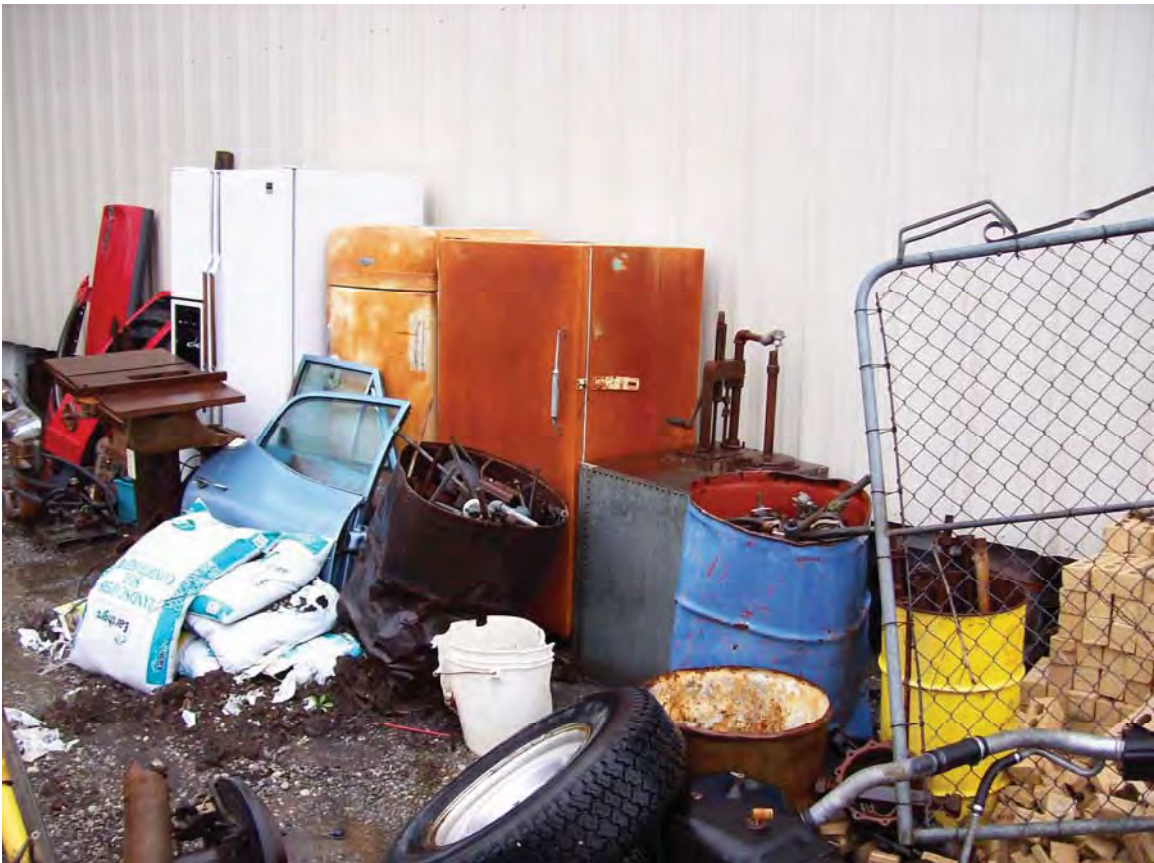
Photograph 12: View looking southeast the kerosene-dispensing AST, drums, and other debris on the north side of the shop building.

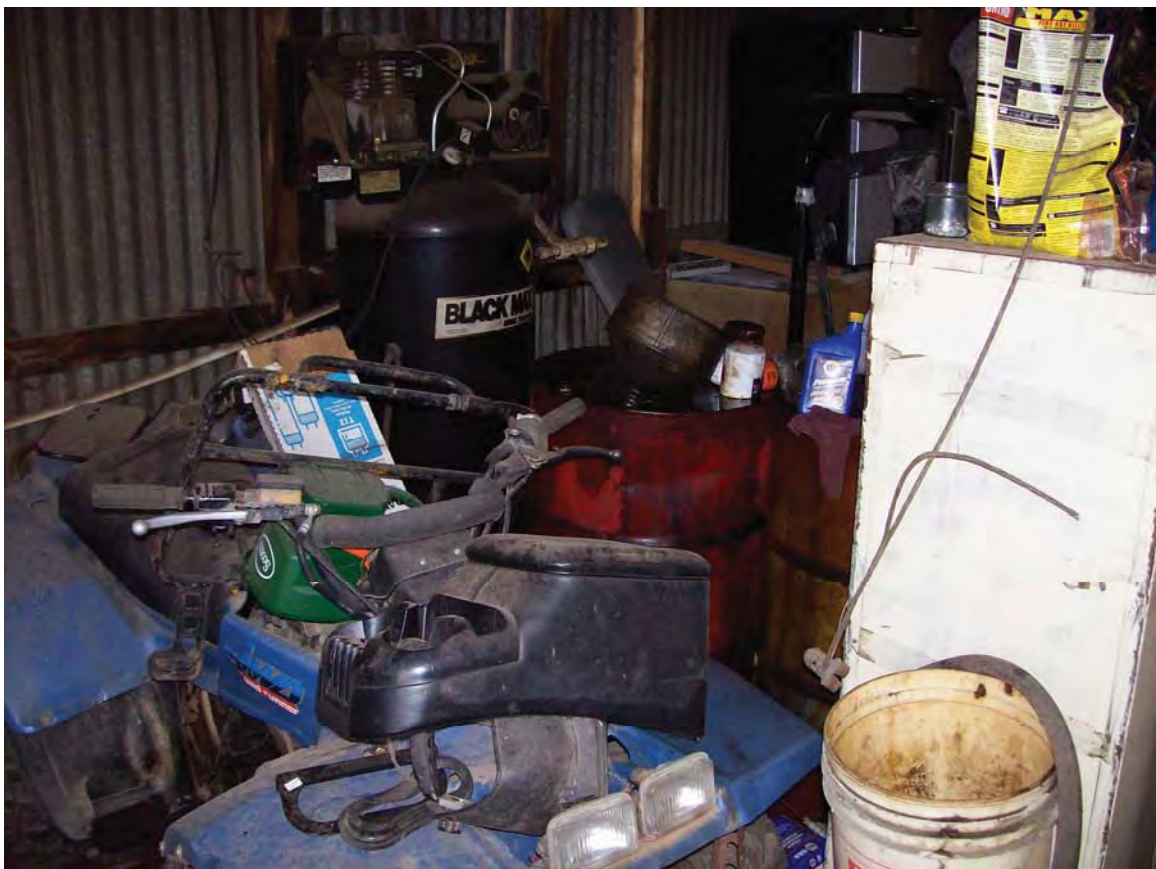
Photograph 13: View inside the shop building of equipment, parts, and new and used oil containers and drums.

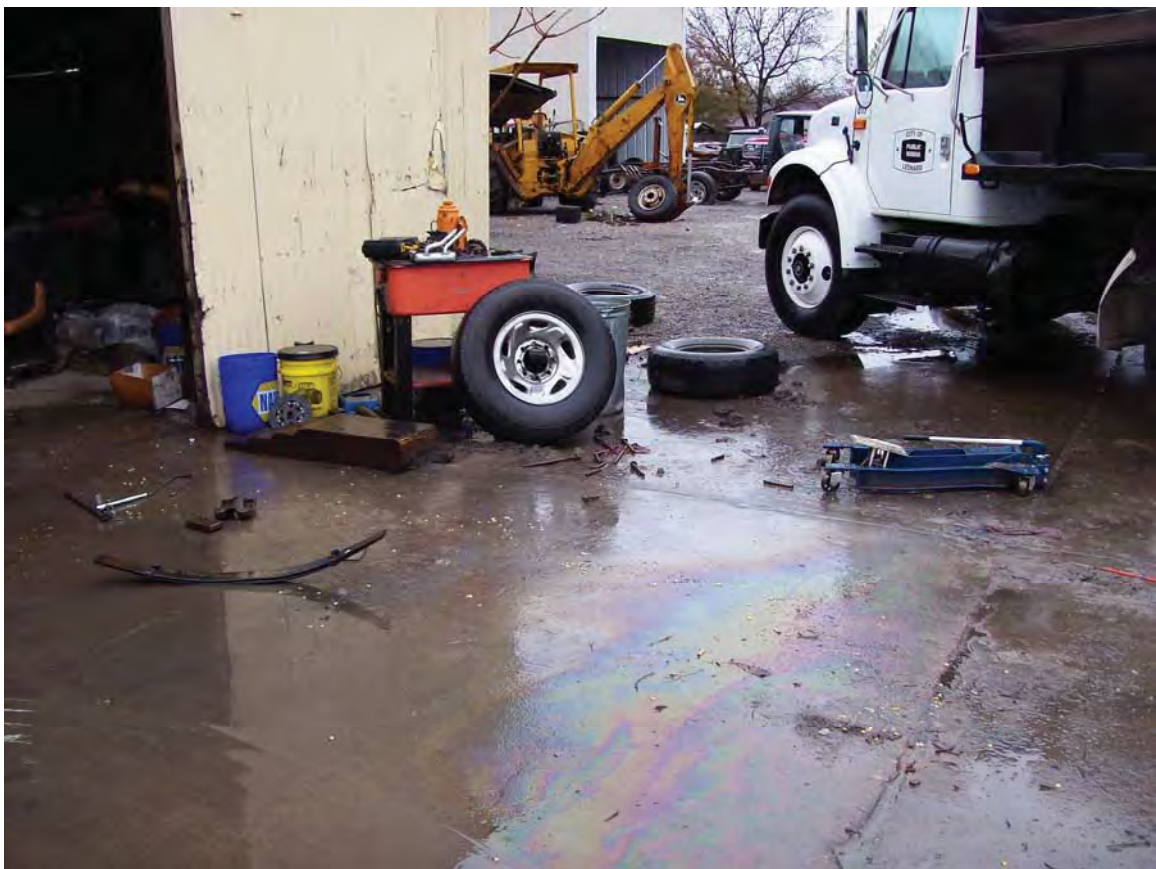
Photograph 14: View looking northwest of the rainbow hydrocarbon sheen visible on the concrete driveway near the shop building.

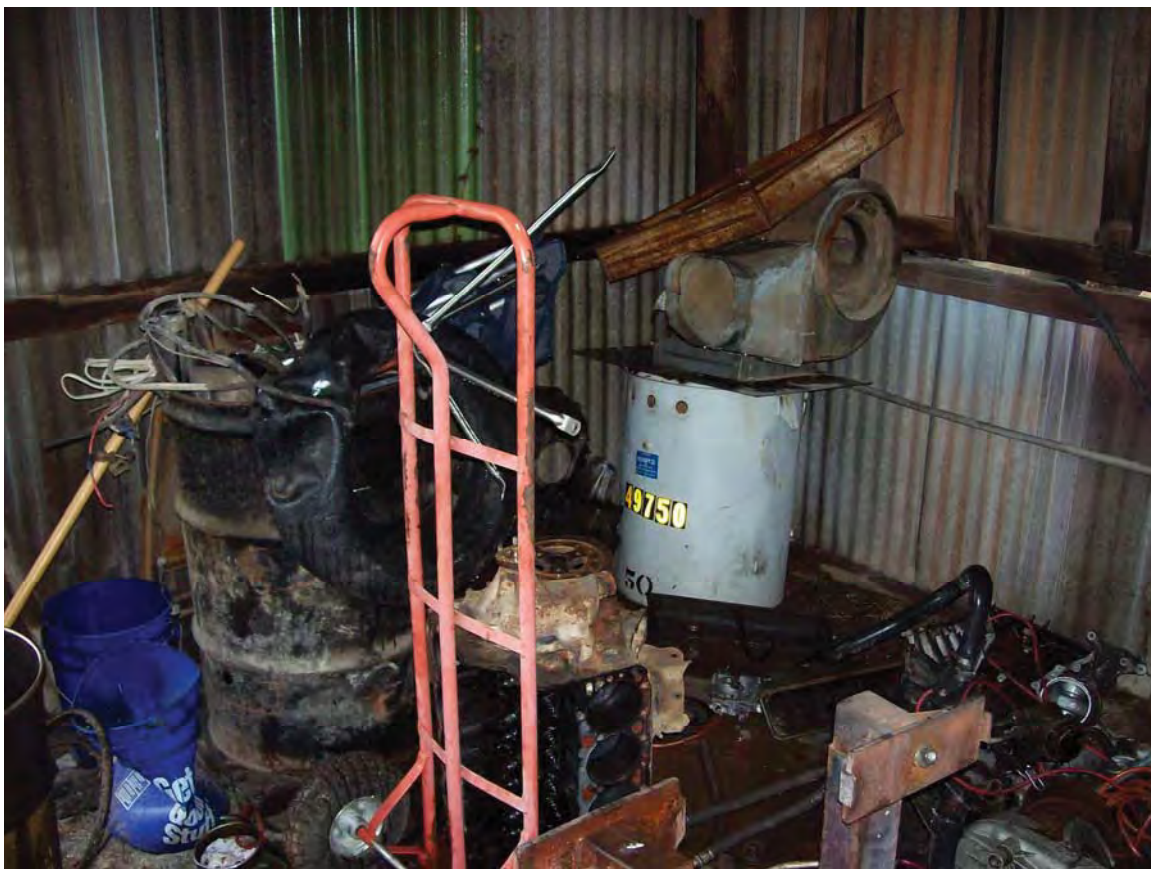
Photograph 15: View inside the shop building showing the leftover transformer from the salvage business. Note the blue “No PCB” sticker on the transformer. This area is where the furnace used for burning the insulation from the transformer was located.

Transformer were salvaged, oil was drained, and copper was recovered from the salvaged transformers at the site from 1974 to 1999. Initially oil was used as weed killer on site and distributed to others in the community as weed killer. Later recovered oil was stored in aboveground tanks and drums. The land is improved by two buildings, a 2,190 square-foot shop and a 450 square-foot shed. A portable building and a concrete containment sump with three aboveground storage tanks are also present. The site has subsequently been used as a vehicle repair and tire shop.

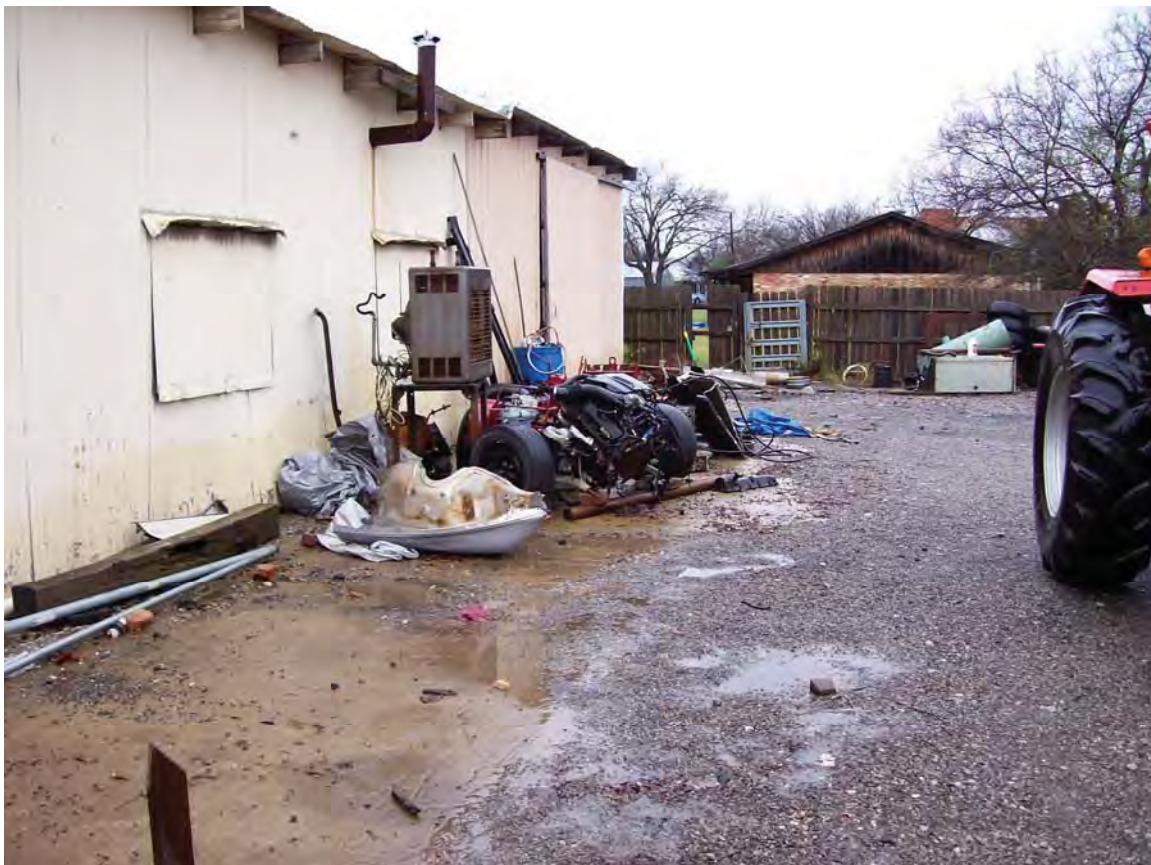
Photograph 16: View looking southwest of the north side of the shop building showing some of the scattered areas of debris and parts.

- Terra-Solve observed numerous unidentified containers on the property, mostly inside and near the shop building and on-site trash cans for authorized disposal. However, a large amount of debris and parts are stored on site.
